DYNAMIC SCIENCE, INC.
In-Depth Accident Investigation

Contract DTNH22-94-A-07049
Case DSI-96-SB-02

TECHNICAL SUMMARY

This case was selected due to a nylon coat drawstring becoming entrapped in a school bus hand rail and the wearer being dragged and run over by the school bus.

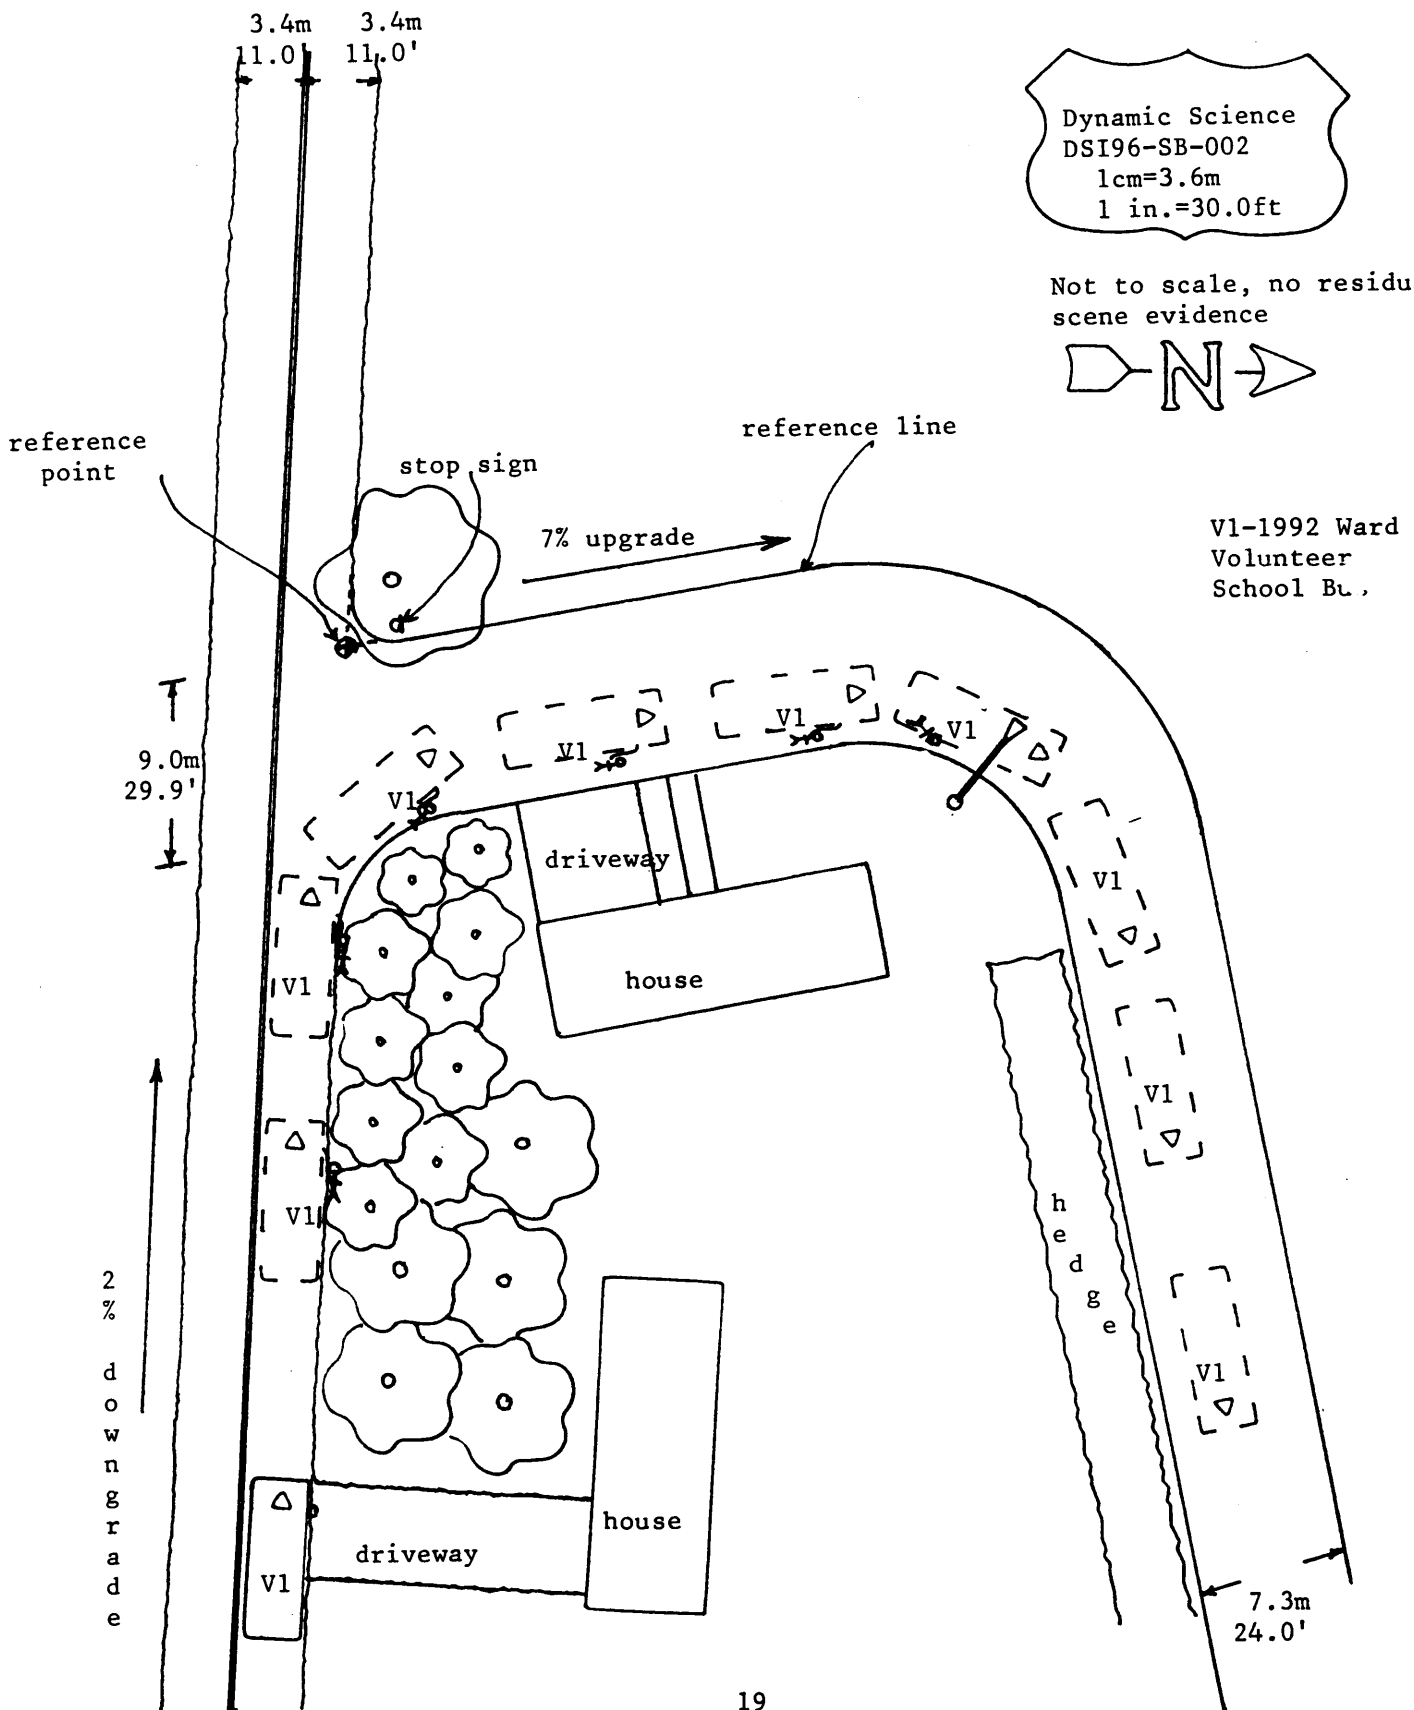
SCENE MEASUREMENTS**Case Number DSI-96-SB-02**

Not to scale, no residual
scene evidence

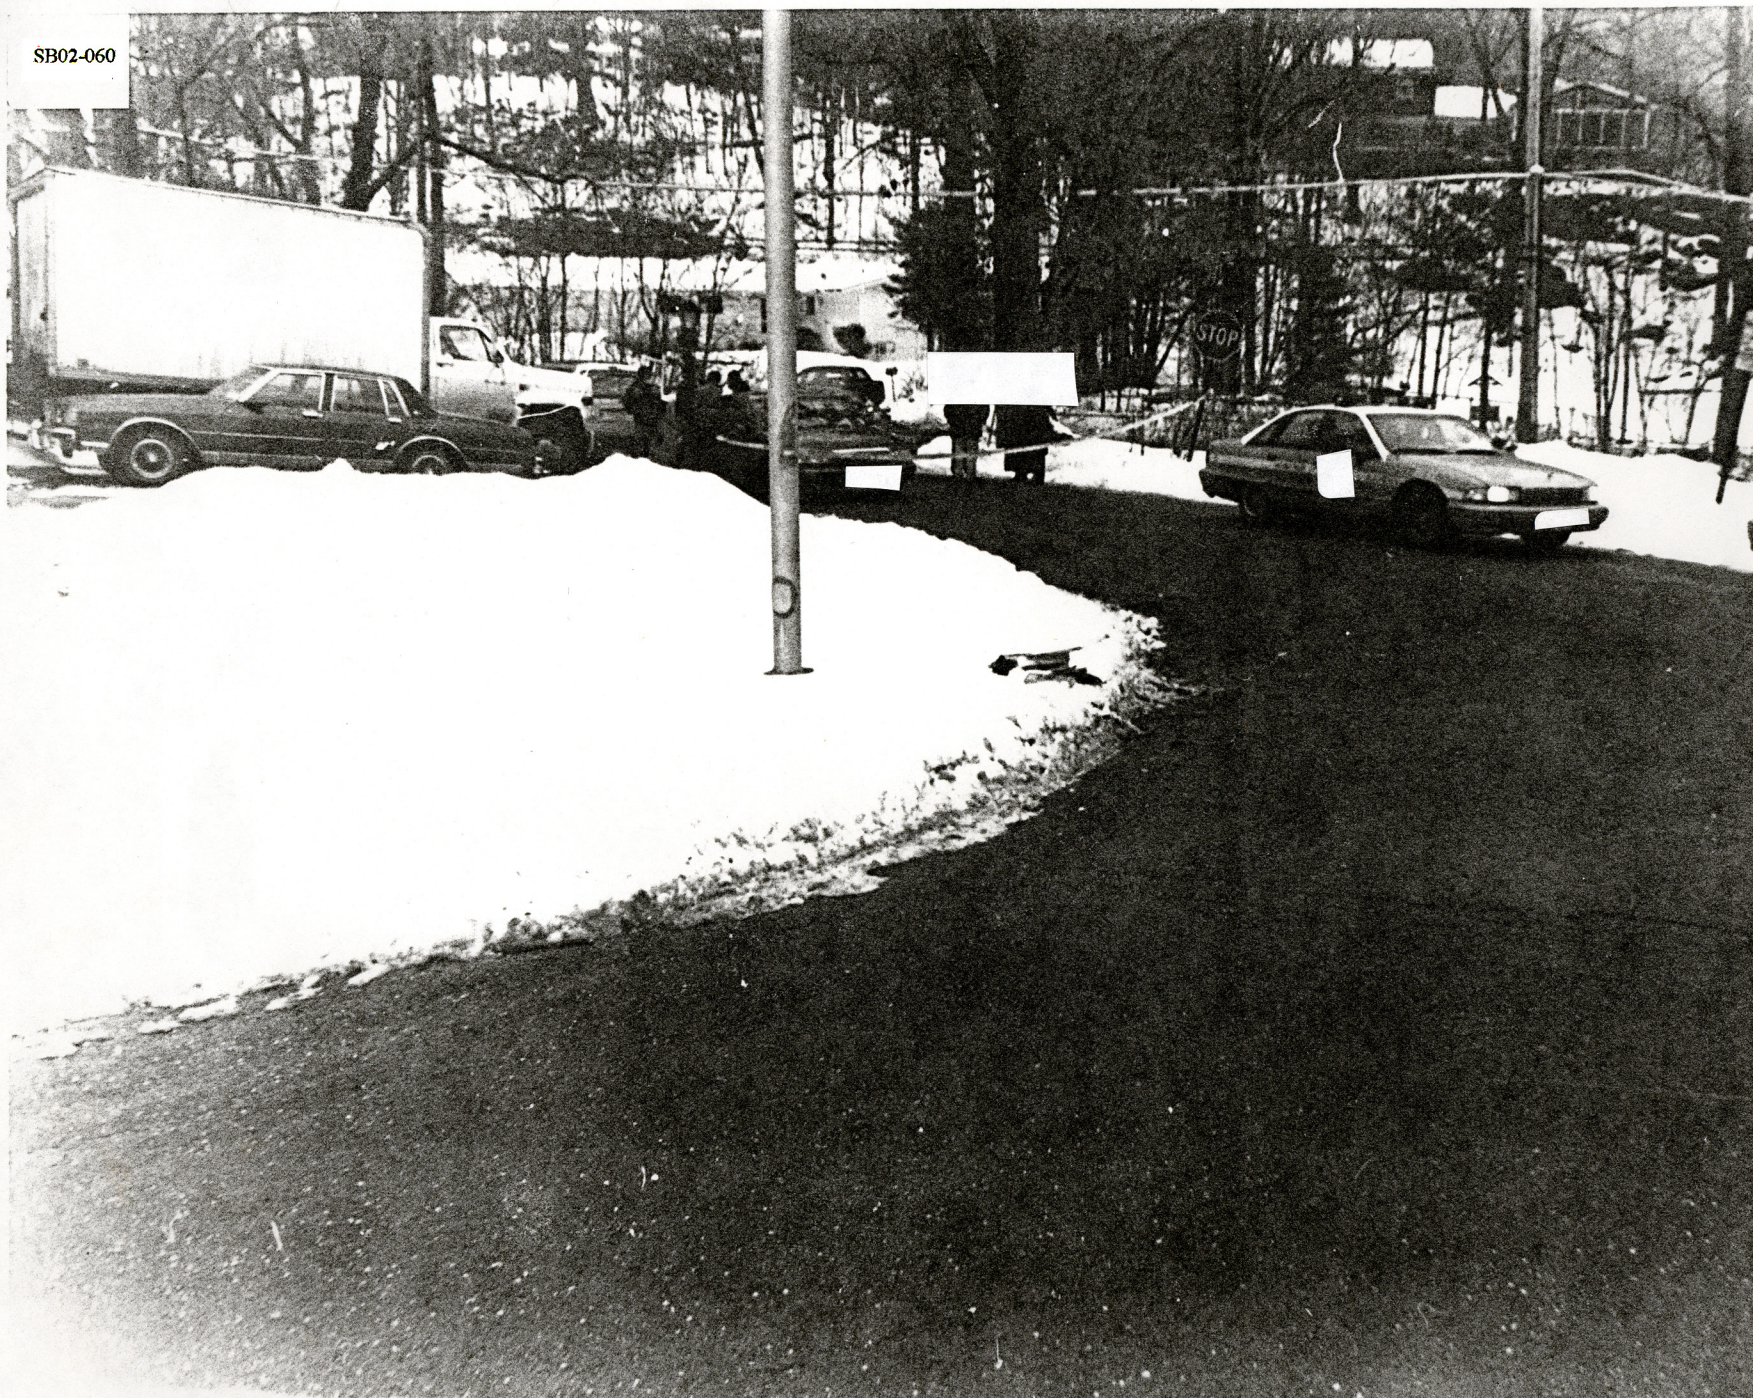
SB02-060

PHOTO NO.	SUBJECT MATTER
60-61	Scene - FRP, books and notebook - case subject
62-63	Vehicle 1, possible pedestrian contacts
64	Vehicle 1, right rear dual wheel
65	Vehicle 1, R/F windshield, Vehicle inspection and registration decals
66	Vehicle 1, stepwell, grab rail and modesty panel
67	Case subject's notebook with abrasion and tread mark
68	Jeans worn by case subject
69	Case subject's coat - front view
70	Case subject's coat - label
71-72	Case subject's coat - back view
73	Case subject's coat - drawstring pucker, back view
74	Case subject's coat - drawstring, right side
75-76	Case subject's coat - drawstring and drawstring end bead

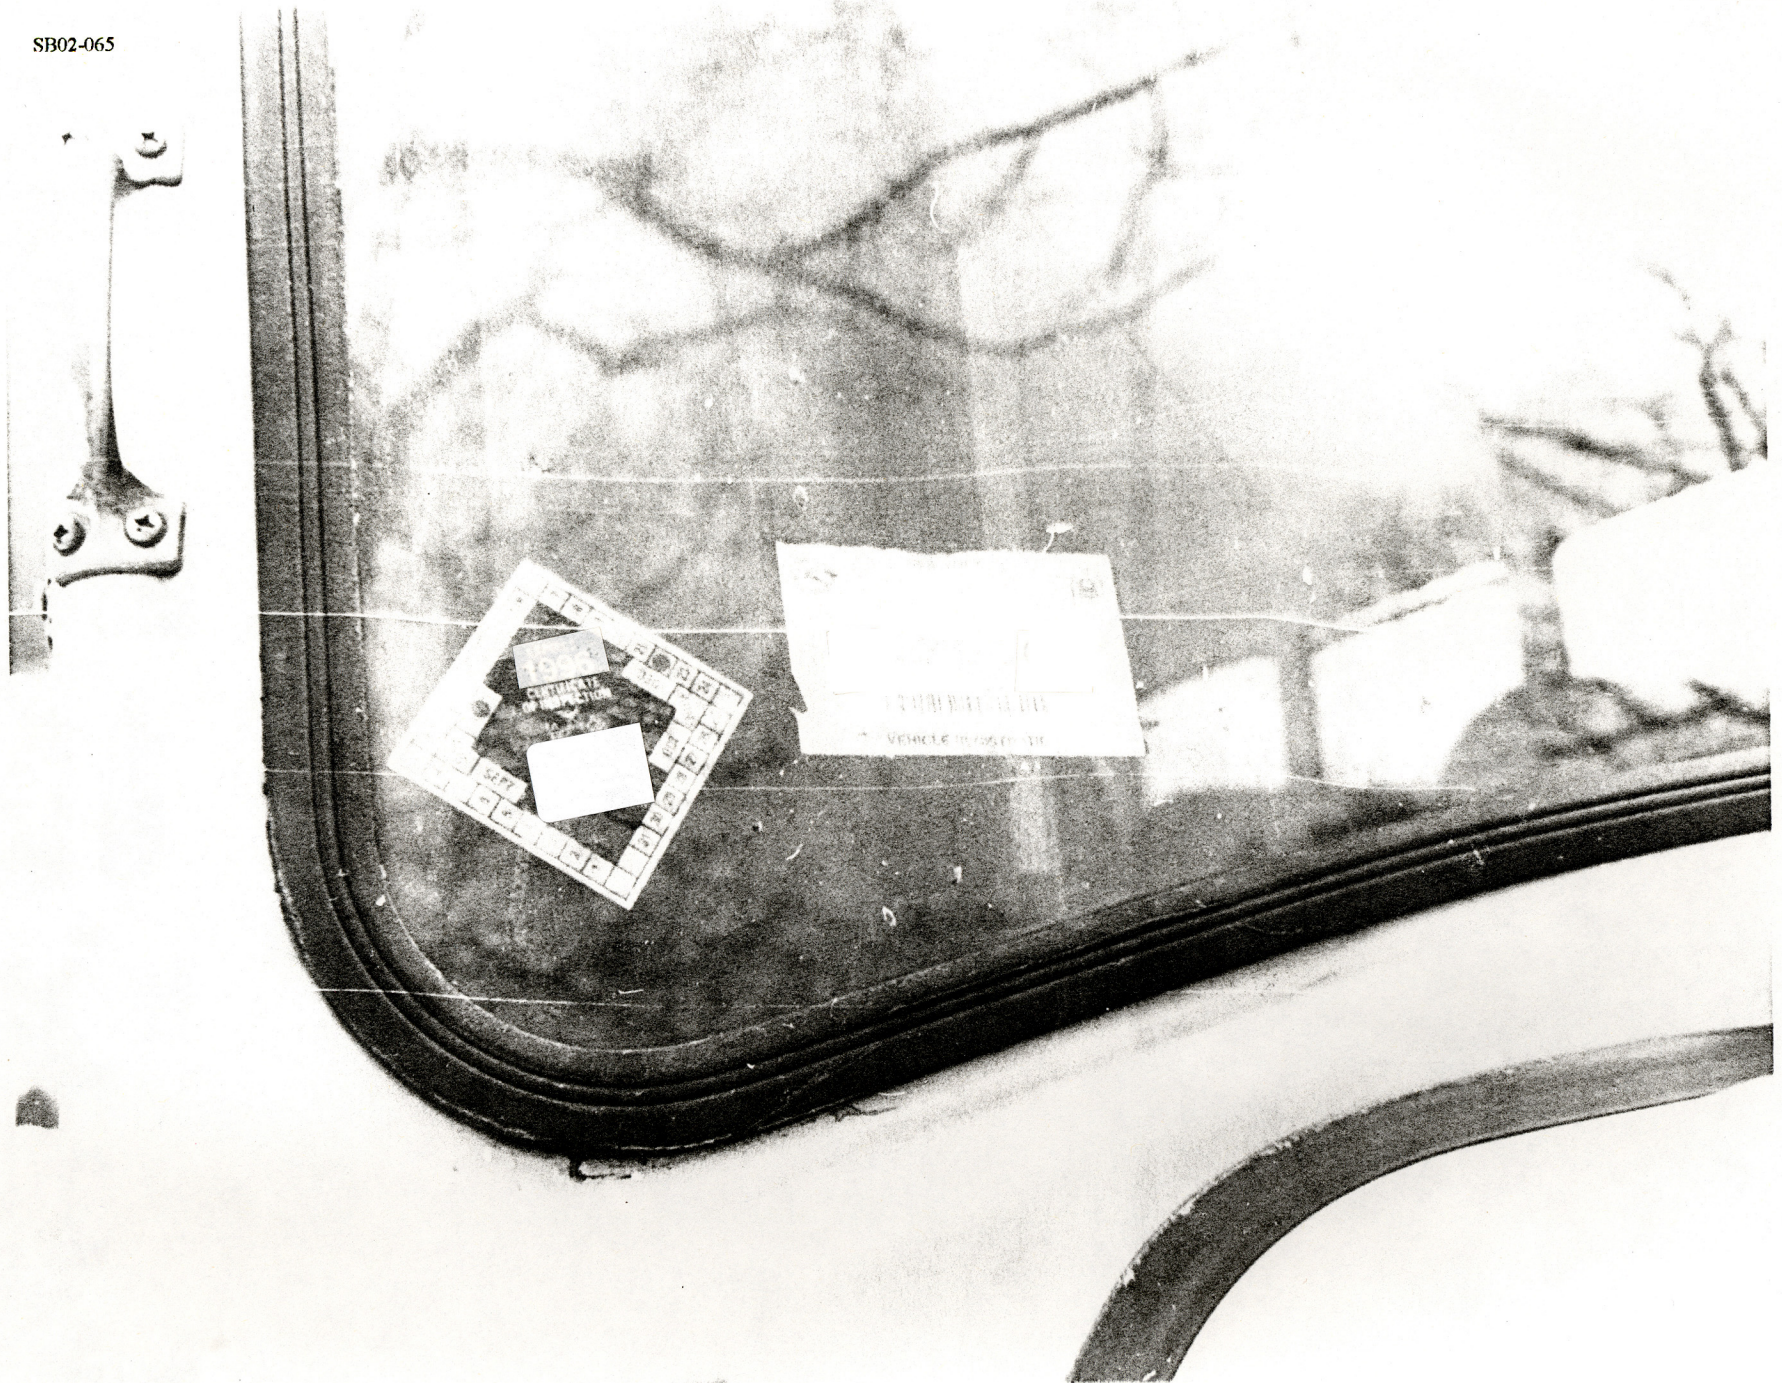
SB02-065

1. DESCRIPTION OF DEFECT: Certain and school buses have a small crevice at the attachment point of the entrance door grab rail to the entrance door body pillar. Also, the space between the grab rail and the modesty panel (if so equipped) may be less than 1 1/2".

When you return the enclosed postage paid reply card, an inspection and repair kit will be sent to you. The remedy will be to install a rubber pad on the grabrail where it attaches to the wall and to move the modesty panel to the rear far enough to attain 1 1/2" of clearance with the grabrail. You may make these repairs yourself or take your vehicle to your dealer on a mutually agreed upon service date. If he does not remedy this condition without charge on or within 5 days, you can obtain assistance by calling Customer Service at the toll free number listed below. You may also wish to submit a

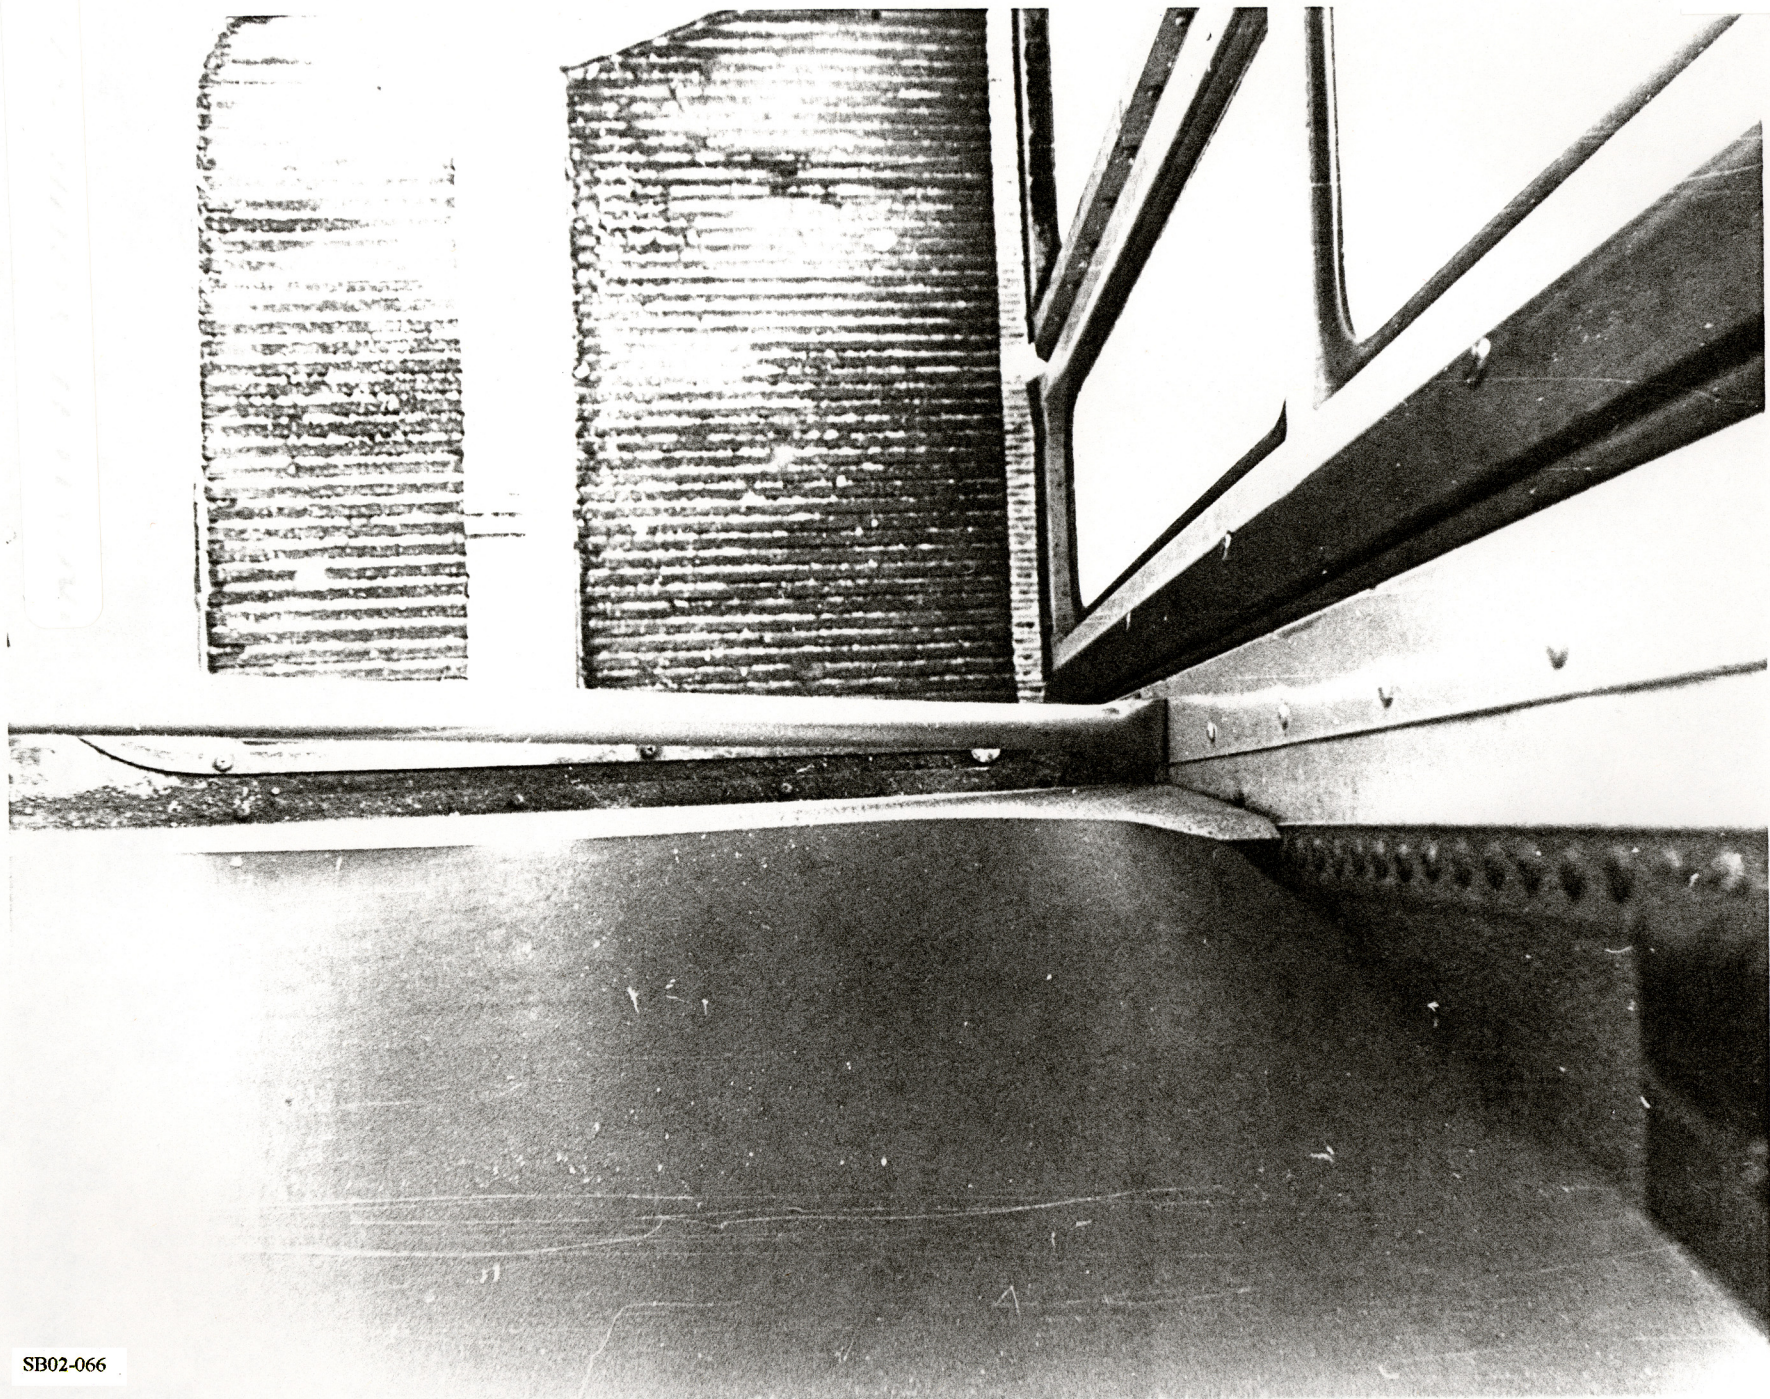
SB02-066

If you are the owner, this is to notify you that your bus may have a defect in the attachment of the handrail located inside rear of the entrance door. A small gap may exist at the attachment of the grabrail to the wall. Also, insufficient clearance may exist between the modesty panel (located on the bottom of the crash barrier) and the grabrail. Certain small objects may be caught in these areas such as coat tie strings. Should this happen, and the driver is unaware of the situation, the person may exit the bus with the string caught in the crevice. The door may be closed and the bus moved causing possible injury to the passenger.
